***Seawall Evaluation Report  
Kinnickinnic River, Wisconsin  
Milwaukee Estuary Area of Concern  
Sediment Removal Concept Design***

***Prepared for  
U.S. Army Corps of Engineers  
Detroit District***

***July 2003***

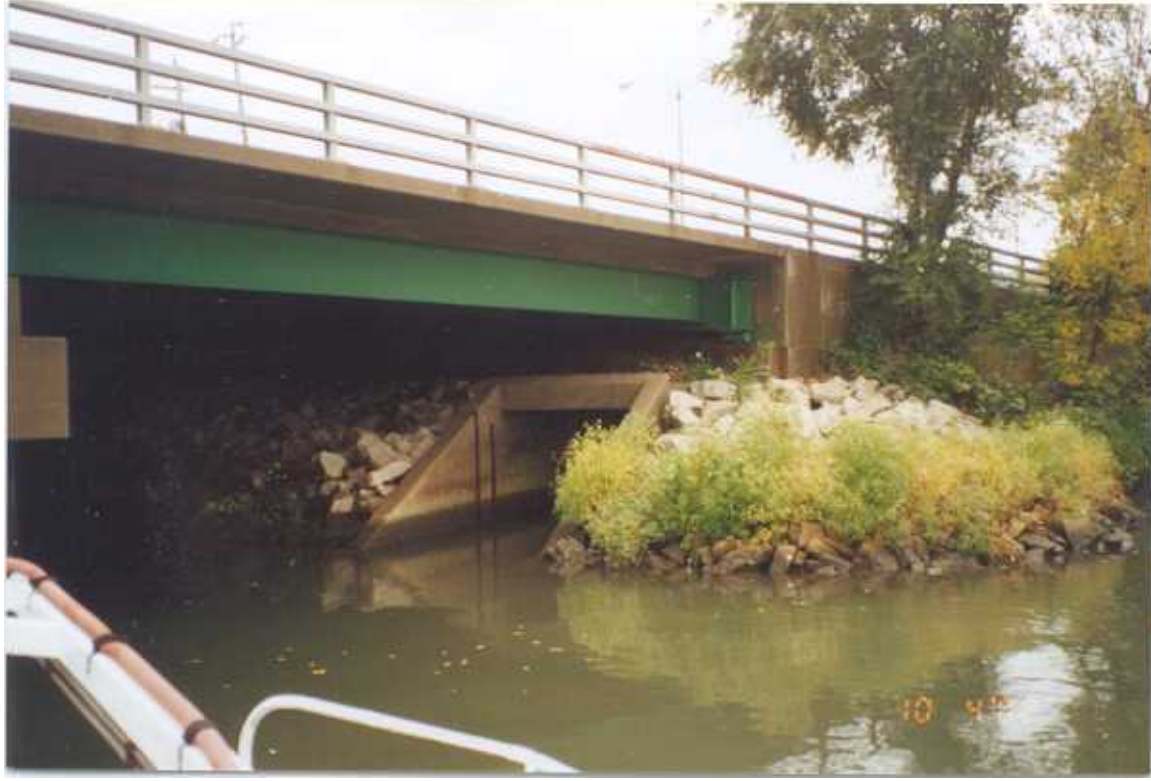
**PHOTO 2 – October 4, 2002 – Kinnickinnic River  
Taken by Tor Hansen, Barr Engineering  
Left abutment Becher Street Bridge showing concrete box  
stormwater outlet. Taken from boat in river while looking  
southwest.**

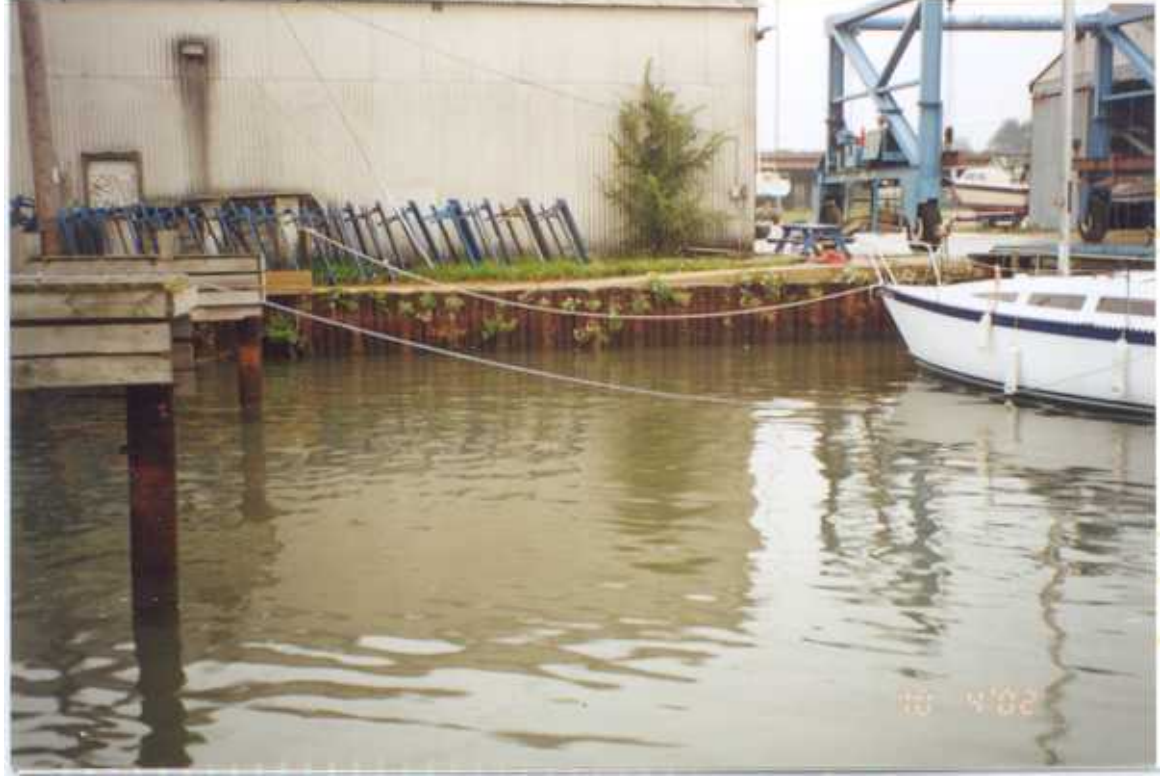
The wall along this parcel is an anchored SSP wall approximately 385 feet long. According to permits 104-C and 128-C the wall is 34 feet deep and was constructed in 1936 and 1941. The wall appears to be in good condition with no visible settlement or movement. There are permanent boat slips constructed on 9-inch pipe piles driven into the river bottom along the wall. A concrete box stormwater outlet at the upstream end of the property is in good condition.

PHOTO 3 – October 4, 2002 – Kinnickinnic River  
Taken by Tor Hansen, Barr Engineering  
Concrete box stormwater outlet and upstream end of steel sheet  
pile wall along Parcel 429. Taken from boat looking west.

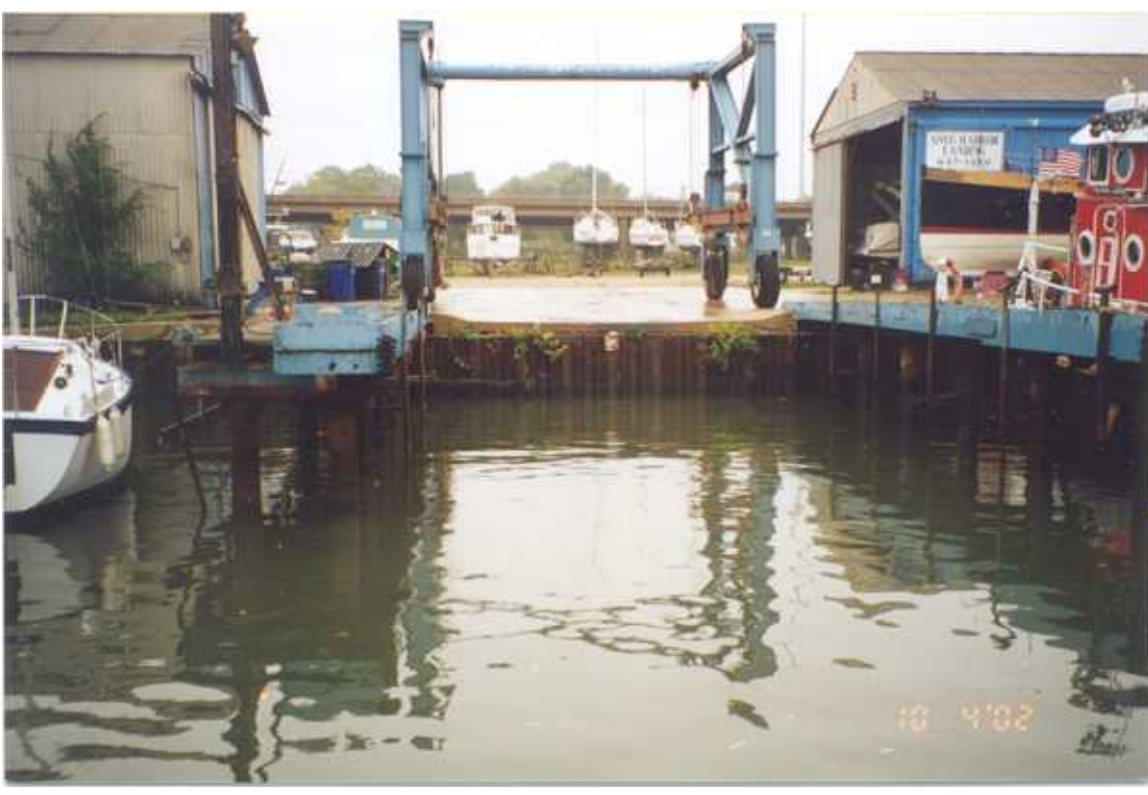
**PHOTO 5 – October 4, 2002 – Kinnickinnic River**  
 Taken by Tor Hansen, Barr Engineering  
 Steel sheet pile wall along Parcel 429. Looking west.

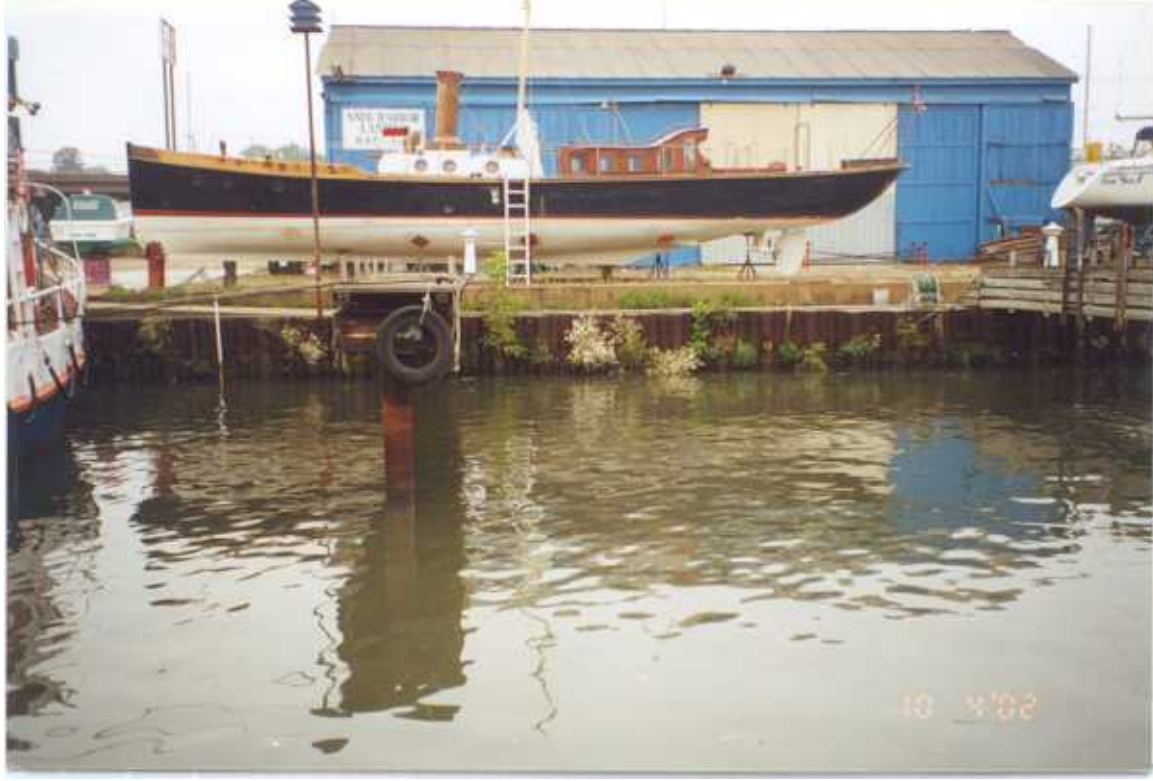
**PHOTO 6 – October 4, 2002 – Kinnickinnic River**  
 Taken by Tor Hansen, Barr Engineering  
 Steel sheet pile wall along Parcel 429. Looking west.

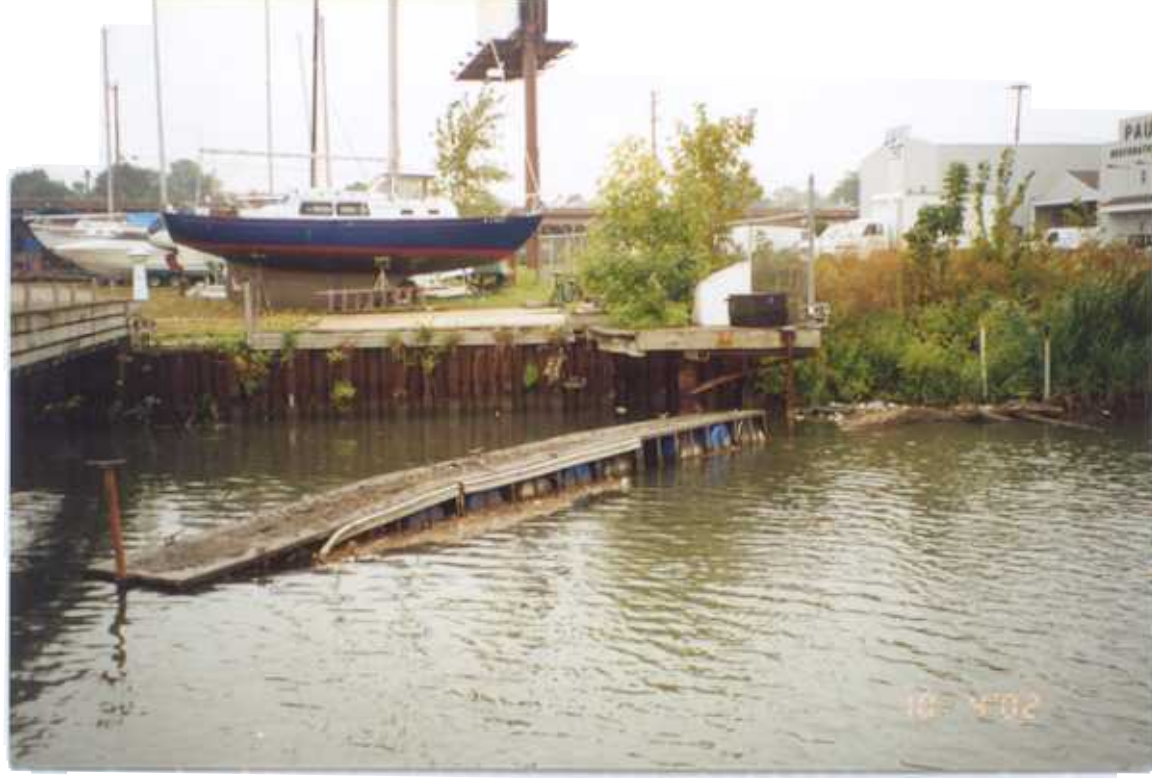
PHOTO 10 – October 4, 2002 – Kinnickinnic River  
Taken by Tor Hansen, Barr Engineering  
Downstream end of steel sheet pile wall along Parcel 429 and  
upstream end of Parcel 428 showing vegetative cover at shoreline.  
Looking west.

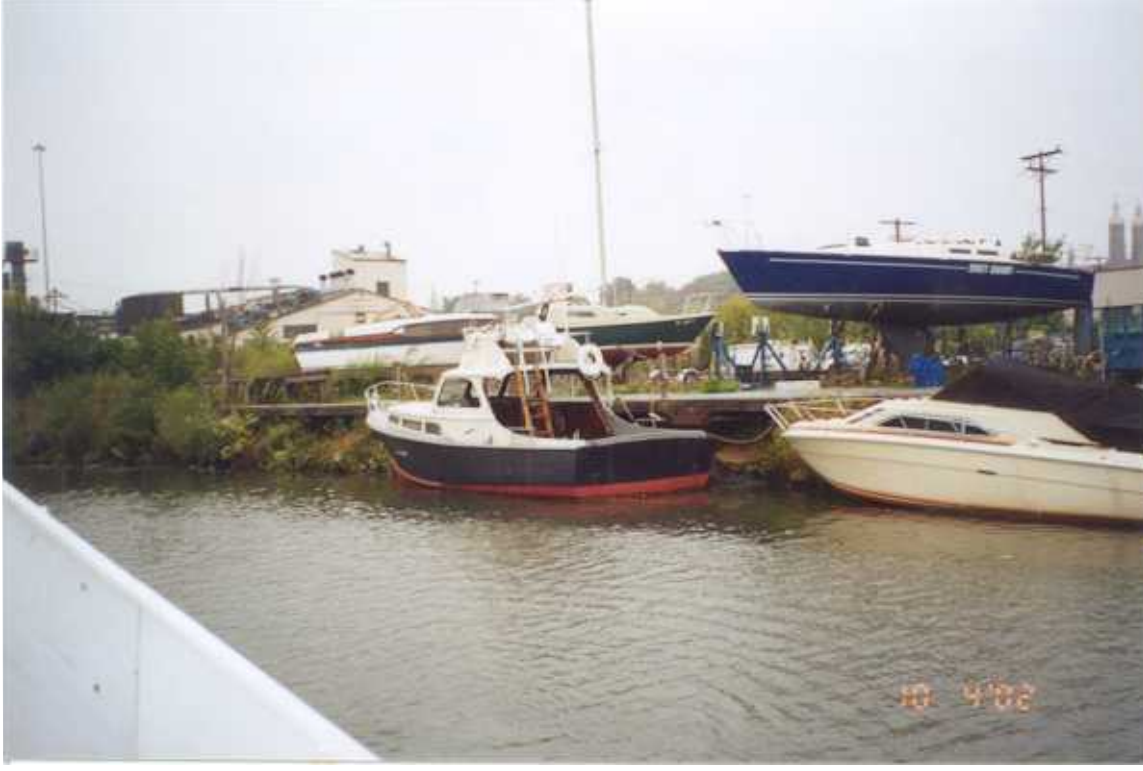
PHOTO 18 – October 4, 2002 – Kinnickinnic River  
Taken by Tor Hansen, Barr Engineering  
Upstream end of Parcel 426B with timber dock. Looking north.

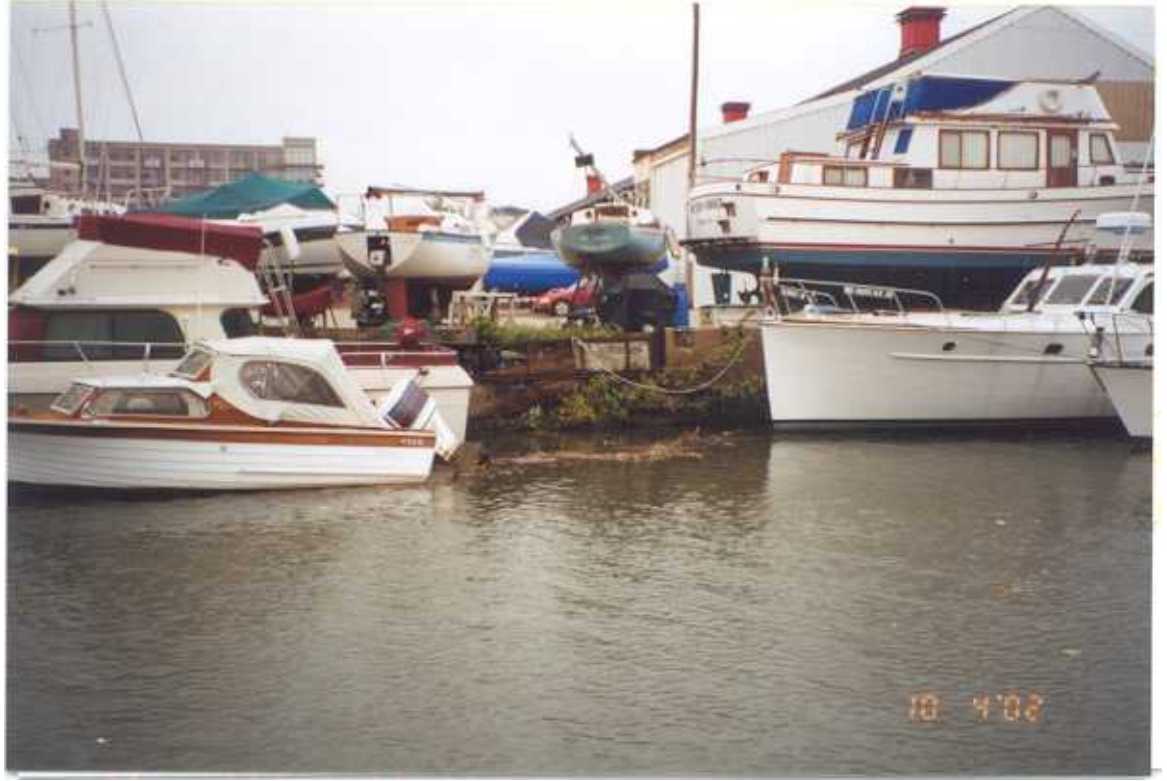
The Wakefield timber walls as shown on records and observed were either in poor condition or no longer in existence. These walls were found on all or portions of Parcels 425, 426A, 426B, 440, 441, 442, and 443. For the walls immediately lining the river in Parcels 425, 426A and 426B, dredging the channel would likely have a negative effect on these walls due to their poor condition, age, and because records indicate they are not embedded as deeply as more recent SSP walls. For the walls either missing or far inland from the river bank as found in Parcels 440 through 443, dredging would not affect these sections of the river bank. Recommendations for stabilizing or strengthening these walls during dredging are included in Section 5.0.

PHOTO 23 – October 4, 2002 – Kinnickinnic River  
Taken by Tor Hansen, Barr Engineering  
Timber dock and wall along Parcel 426B. Looking north.

The Wakefield timber walls are generally in poor condition and should be protected during dredging operations. The recommended means for strengthening these walls is to construct new SSP walls immediately adjacent to the existing timber walls. The new walls would remain in place as permanent structures. Depending on site constraints and loading, the walls could be either anchored or cantilevered SSP walls. The approximate length requiring protection is 450 feet. The new steel SSP sheets will be approximately 40 feet long based on the records for existing SSP walls along this area of the river. At a cost of \$20 per square foot (based on recent bid tabs), this equates to a protection cost of \$360,000. Add in costs for fill material and contingency and the total protection cost is on the order of magnitude of \$500,000. This estimate is preliminary and actual costs will be affected by site conditions, final design, and market conditions.

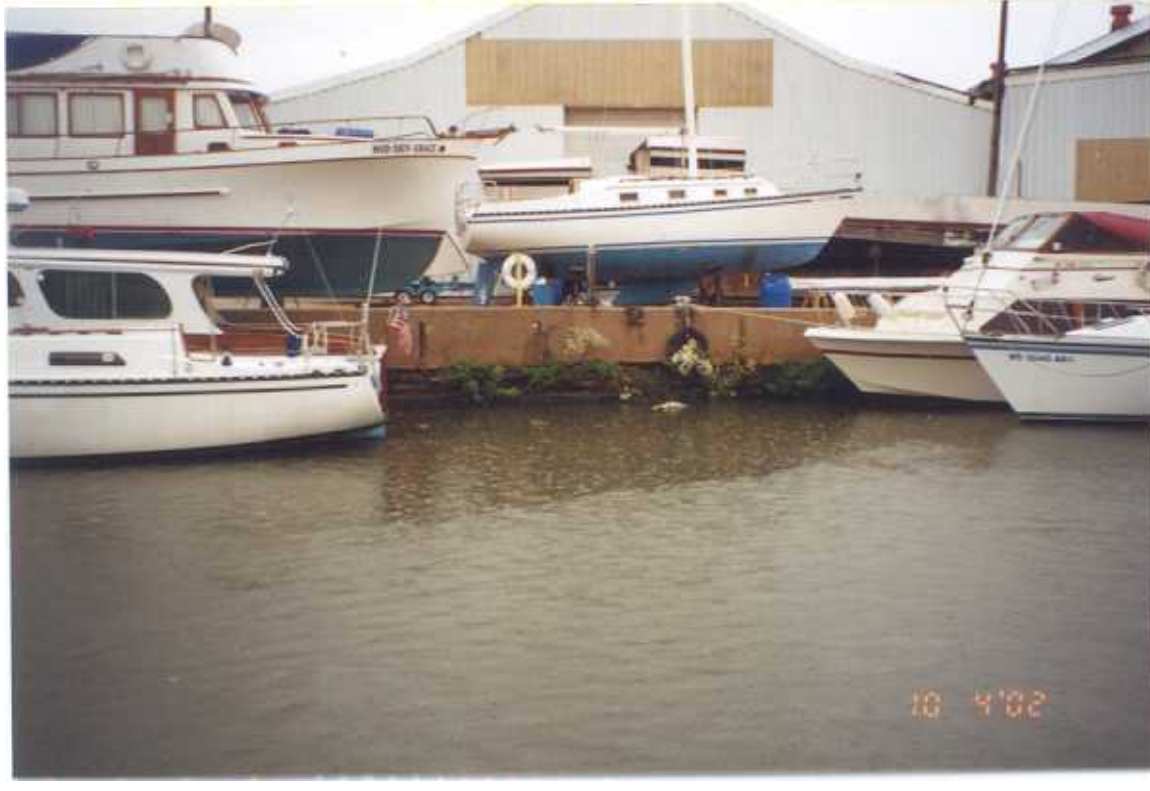
Records for this 385-foot section of the river indicate a Wakefield timber wall constructed in 194 and 1942. Most of this wall is permitted under Permit Number 131-R. The downstream most 90 feet is covered under Permit 138-R which indicates 28-foot long Wakefield timbers and 50-foot timber support piles. There is a concrete dock built on top and adjacent to the old wall. The concrete dock is not detailed on available records. In general, the wall and dock appear to be in fair to good condition, however, much of the Wakefield timber wall was not visible. There are no visible signs of distress or movement in the wall. Some spalling and deterioration of the concrete is present.

PHOTO 25 – October 4, 2002 – Kinnickinnic River  
Taken by Tor Hansen, Barr Engineering  
Concrete dock and timber wall at Parcel 426A. Looking north.

These walls are in poor condition and should be strengthened similarly to the plain Wakefield timber walls. The recommended protection method is the same as mentioned in Paragraph 5.3. The approximate length requiring protection is 535 feet. Using 40-foot sheets at \$20 per square foot, the wall cost is \$428,000. Add costs for fill and contingency and the total protection cost is on the order of magnitude of

\$600,000. This estimate is preliminary and actual costs will be affected by site conditions, final design, and market conditions.

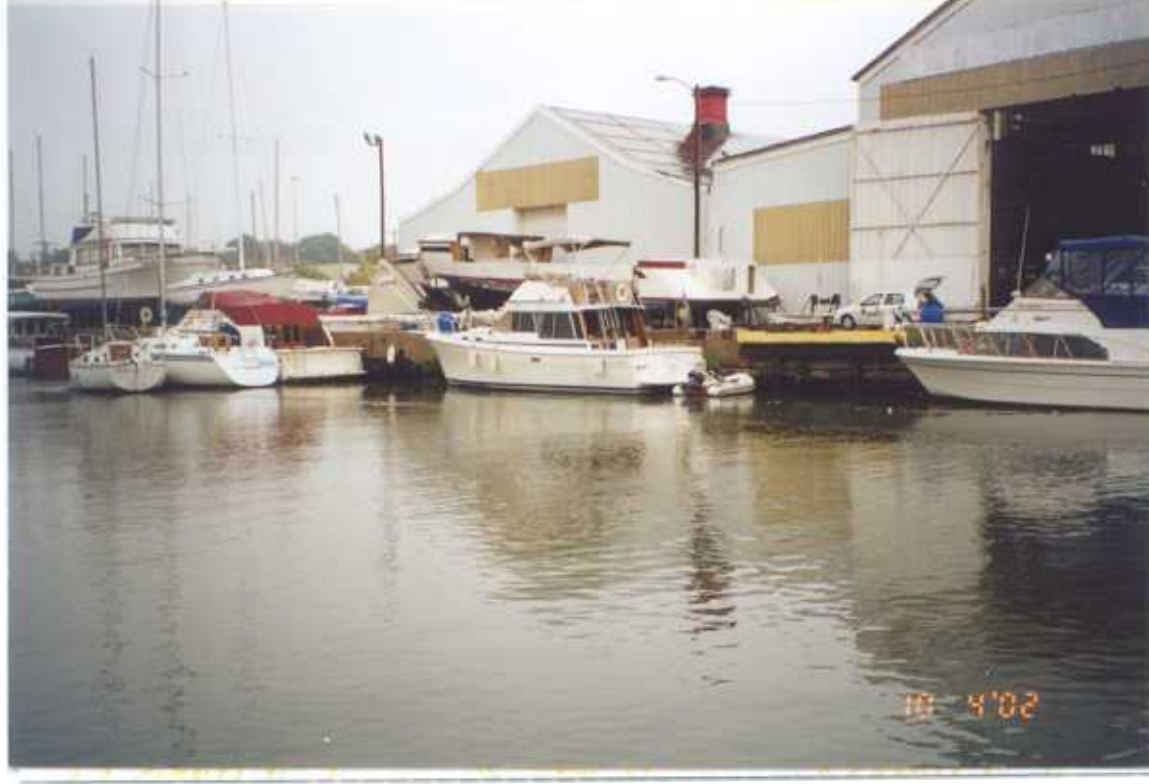
PHOTO 26 – October 4, 2002 – Kinnickinnic River  
Taken by Tor Hansen, Barr Engineering  
Concrete dock and timber wall at Parcel 426A. Looking north.

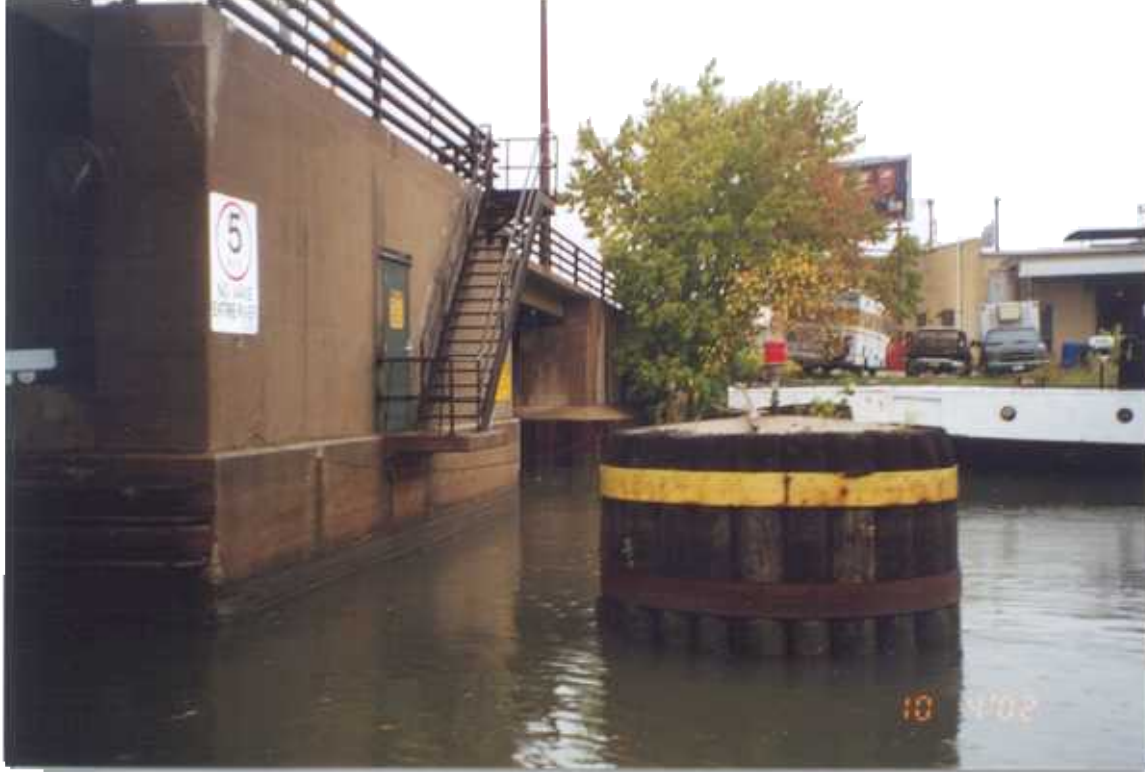
The left bridge abutment for the 1<sup>st</sup> Street Bridge is the river bank along Parcel 426. The abutment consists of a SSP wall and mass concrete section. The abutment is in excellent condition.

PHOTO 29 – October 4, 2002 – Kinnickinnic River  
Taken by Tor Hansen, Barr Engineering  
Downstream face of pier and left abutment for 1<sup>st</sup> Street Bridge.  
Parcel 426 looking north.

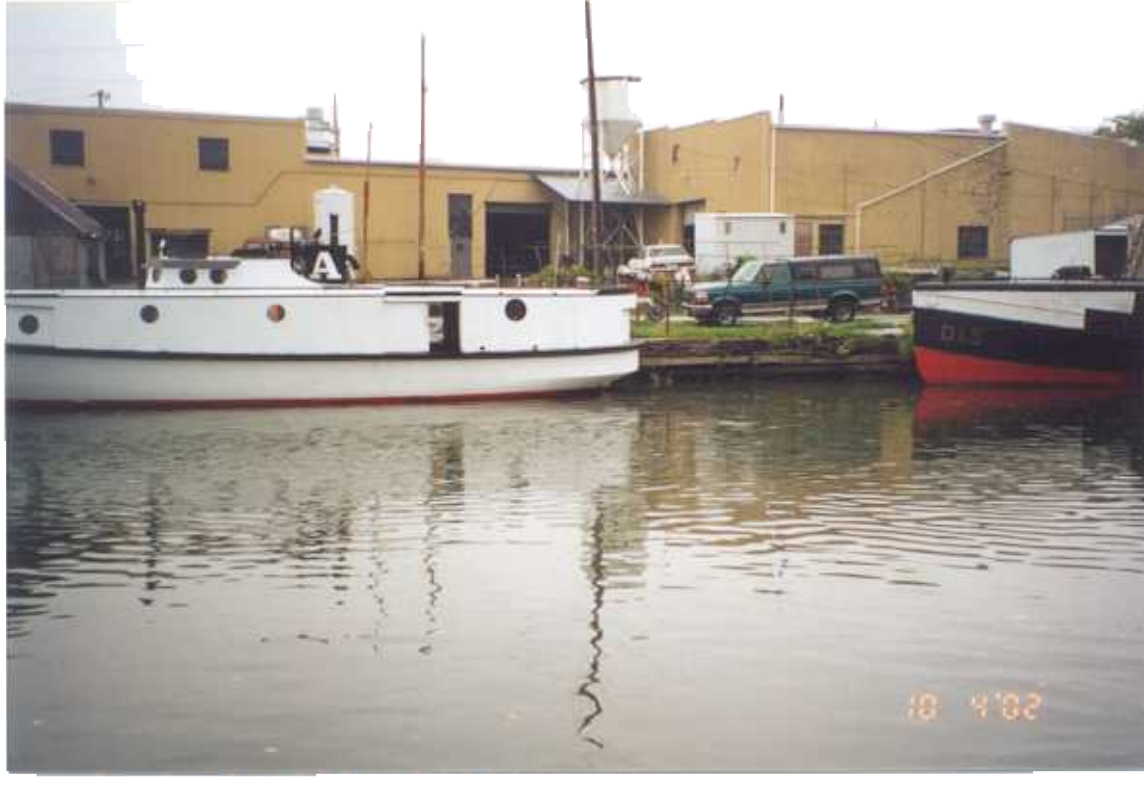
Records for this 693-foot section of the river bank between the 1<sup>st</sup> Street Bridge and the Kinnickinnic Avenue Bridge indicate that no wall exists. However, some portions of this parcel are lined with a timber wall or timber and concrete wall. Roughly 150 feet of this river bank is protected by some sort of timber wall and another roughly 150 feet is protected by a timber and concrete wall. Both sections of wall are in poor condition with rotted wood and spalling concrete at the waterline. The remainder of the river bank within this parcel is unprotected with the river bank contained by vegetation. There is also an old railroad bridge abutment near the downstream end of the parcel just upstream from the Kinnickinnic Avenue Bridge. The abutment is mass concrete and there is some spalling and deterioration of the concrete.

PHOTO 33 – October 4, 2002 – Kinnickinnic River  
Taken by Tor Hansen, Barr Engineering  
Timber wall along Parcel 425. Looking north.

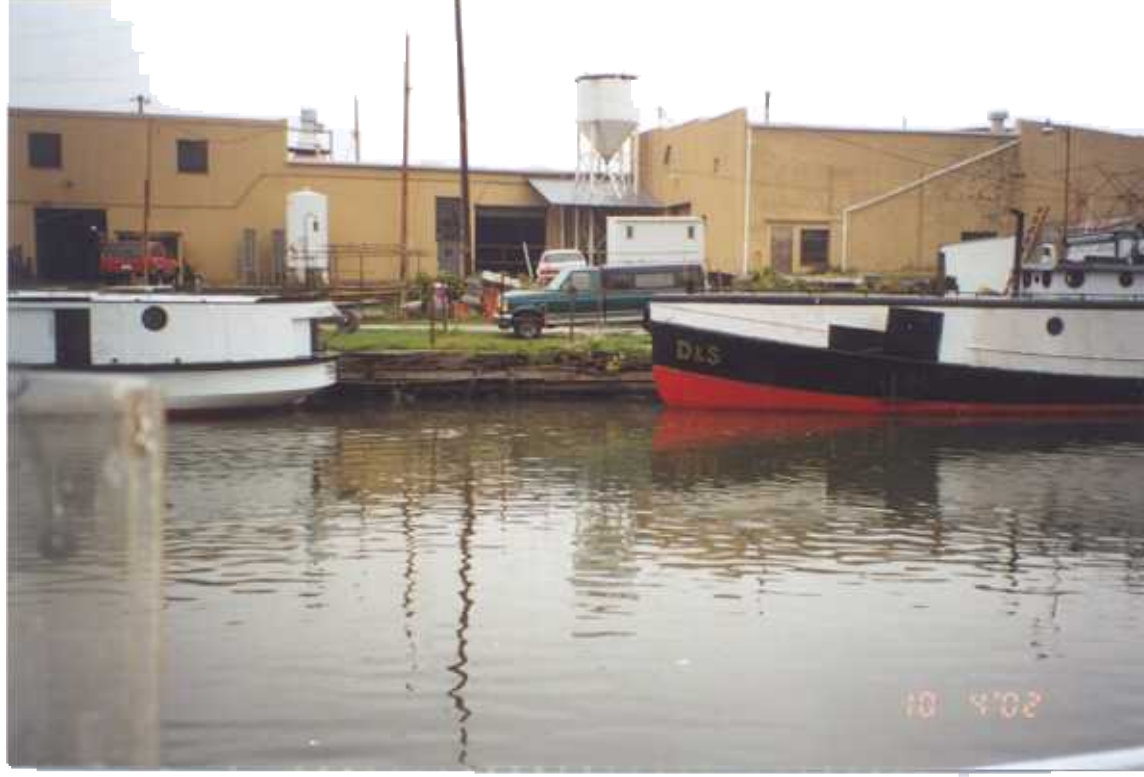
PHOTO 34 – October 4, 2002 – Kinnickinnic River  
Taken by Tor Hansen, Barr Engineering  
Timber wall along Parcel 425. Looking north.

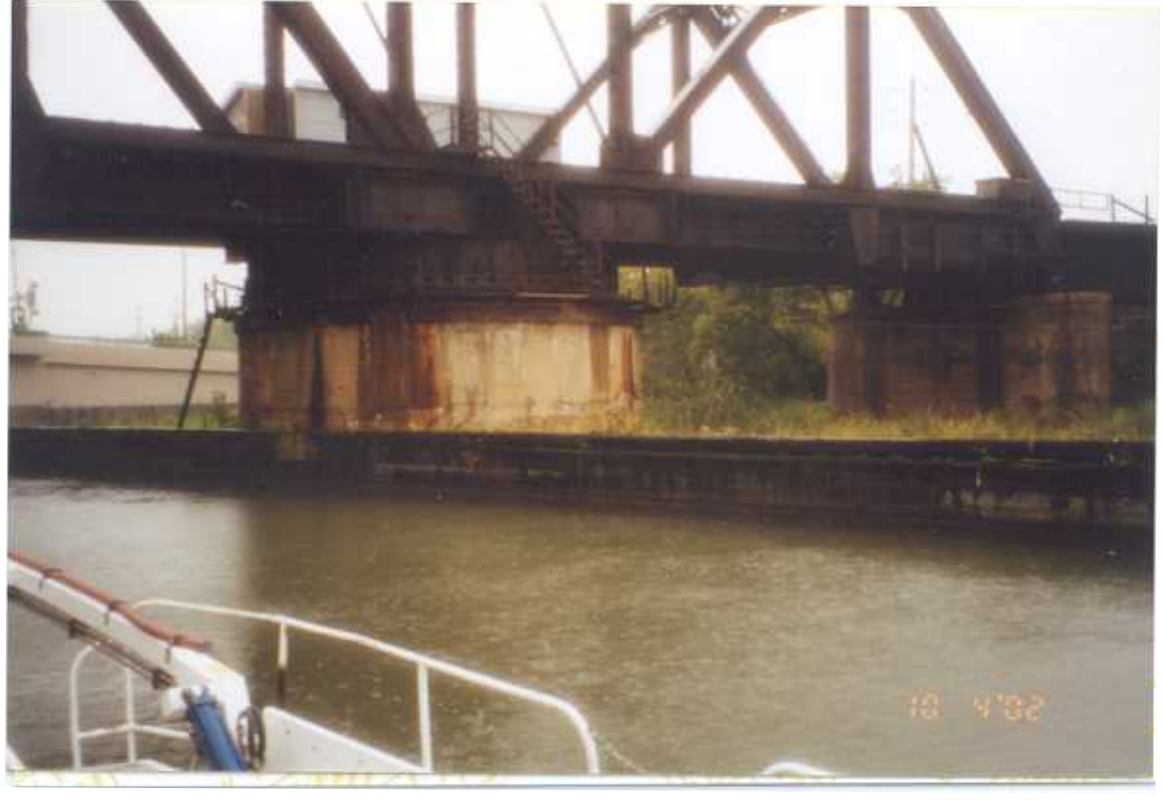
On the right side of the current navigation channel starting at the Kinnickinnic Avenue Bridge and extending upstream 204-feet is an old timber pile protective fence constructed in 1962. It was constructed to protect a railroad concrete bridge pier within the river from barge traffic. If this structure is to remain, any dredging immediately adjacent to it could cause adverse affects. Therefore, the limitations assumed for this report should be followed. If these limitations are exceeded, then additional evaluation of this wall should be completed.

**PHOTO 72 – October 4, 2002 – Kinnickinnic River**  
Taken by Tor Hansen, Barr Engineering  
Timber pile fence protecting bridge pier adjacent to Parcel 443. Looking south.

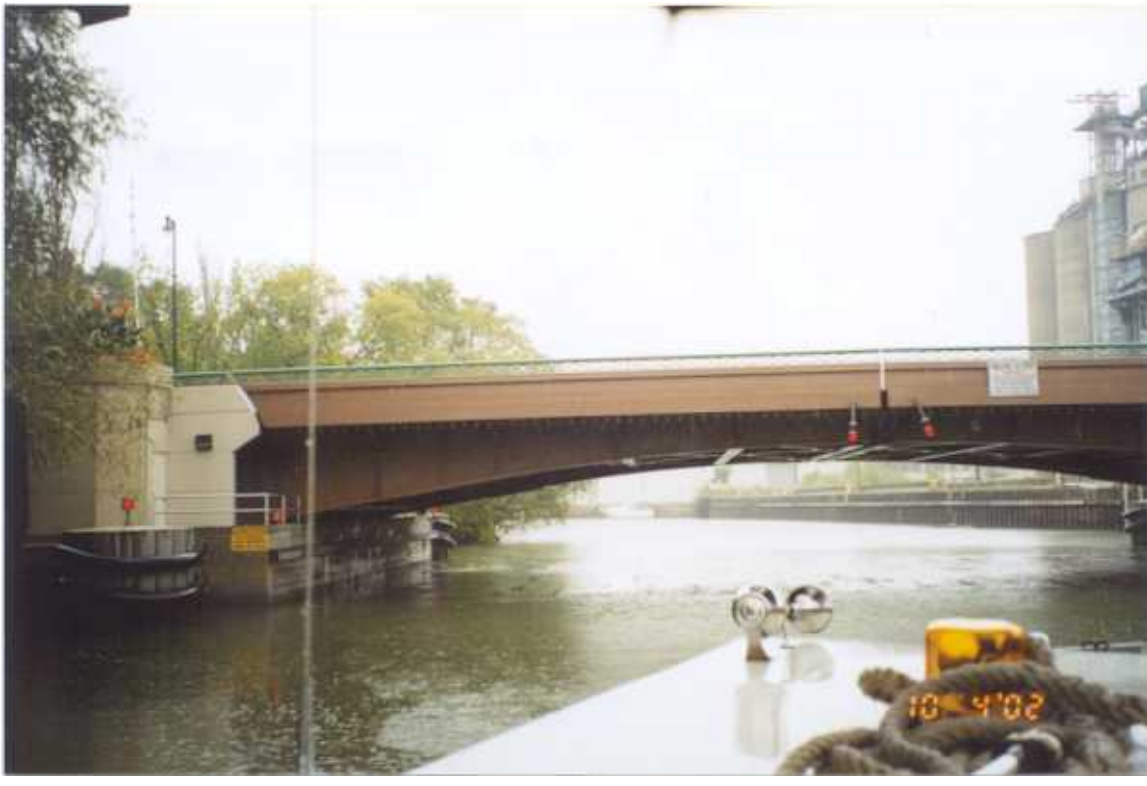
There are four bridge crossings in this stretch of river. Starting at the upstream end is the Becher Street Bridge, moving downstream next comes the 1<sup>st</sup> Avenue Bridge, followed by a railroad bridge, and downstream is the Kinnickinnic Avenue Bridge. The abutments are primarily mass concrete structures in good condition. Based on their mass alone, it is unlikely that limited dredging would affect these structures; however, upon determination of dredging limits, these abutments should be reviewed in detail to assure their stability.

PHOTO 73 – October 4, 2002 – Kinnickinnic River  
Taken by Tor Hansen, Barr Engineering  
Upstream side of Kinnickinnic Avenue Bridge and left abutment.  
Looking east.

Upon finalizing the limits of the dredging, any structures within the vicinity of the excavated channel should be evaluated in detail to determine if dredging will affect their stability. The following recommended tasks should be completed in order to evaluate the structures appropriately.

- Search for records on the design and construction of the structure.
- Complete or research soil borings in the vicinity of the structure to determine the soil types and layers adjacent to the wall.
- If records are found, complete a detailed analysis of the structure to determine if the planned excavation limits will adversely affect the stability of the structure.

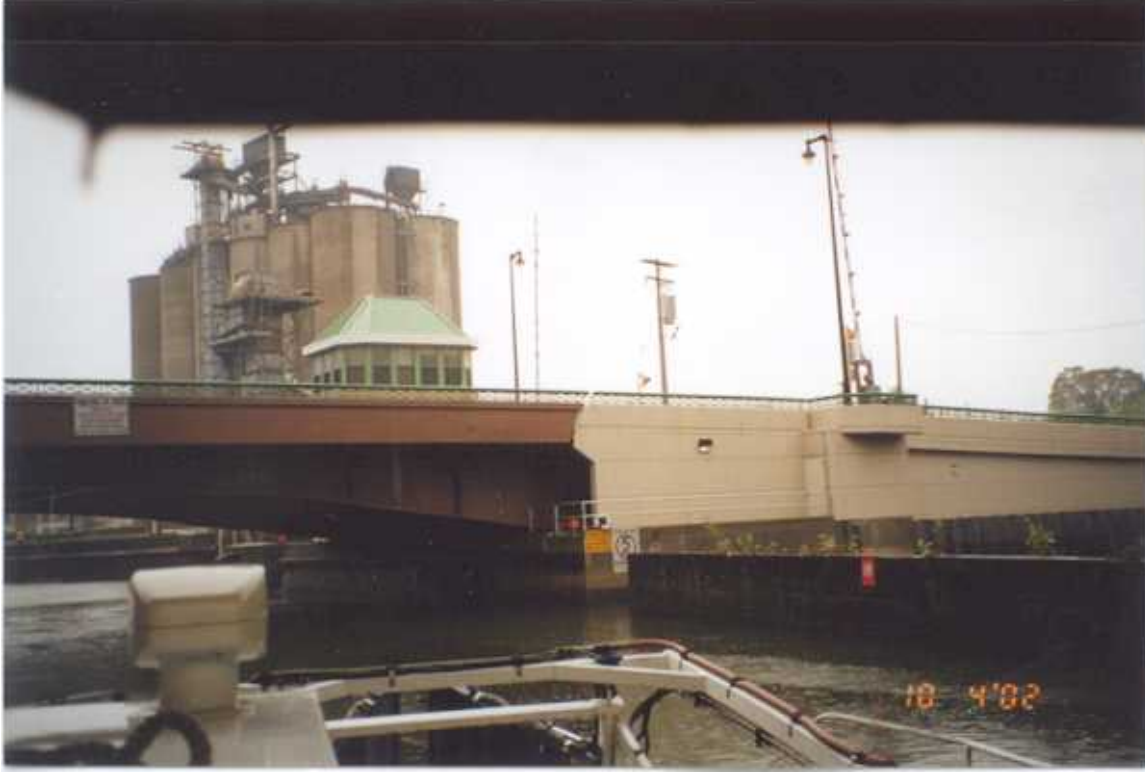
PHOTO 74 – October 4, 2002 – Kinnickinnic River  
Taken by Tor Hansen, Barr Engineering  
Upstream side of Kinnickinnic Avenue Bridge and right abutment.  
Looking east.
